Waterproofing system under mastic asphalt (OS 10)

Triflex AWS

System drawings

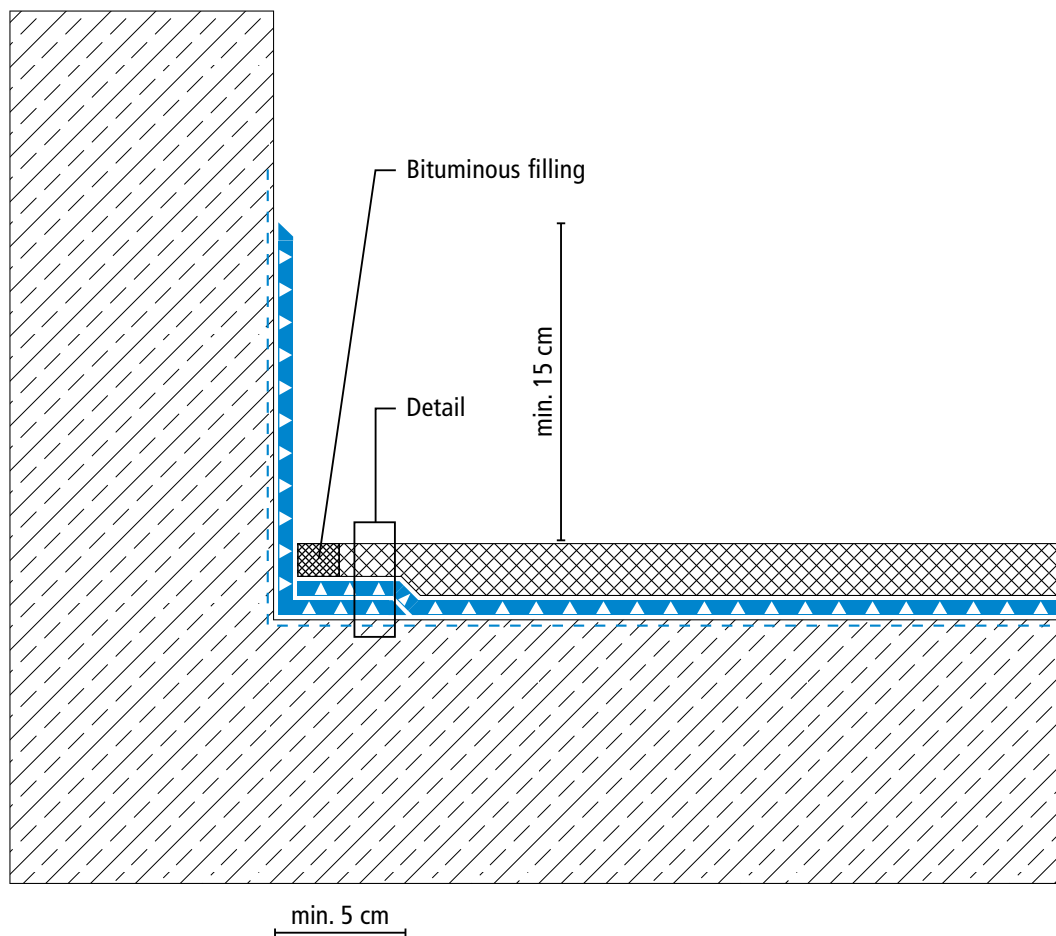
Wall junction

System set-up – Detail
